FINAL REPORT

State Commission on Aircraft Accidents Investigation (PKBWL)

OCCURRENCE NO – 2021/1037

AIRCRAFT – Tecnam Astore, I-C326

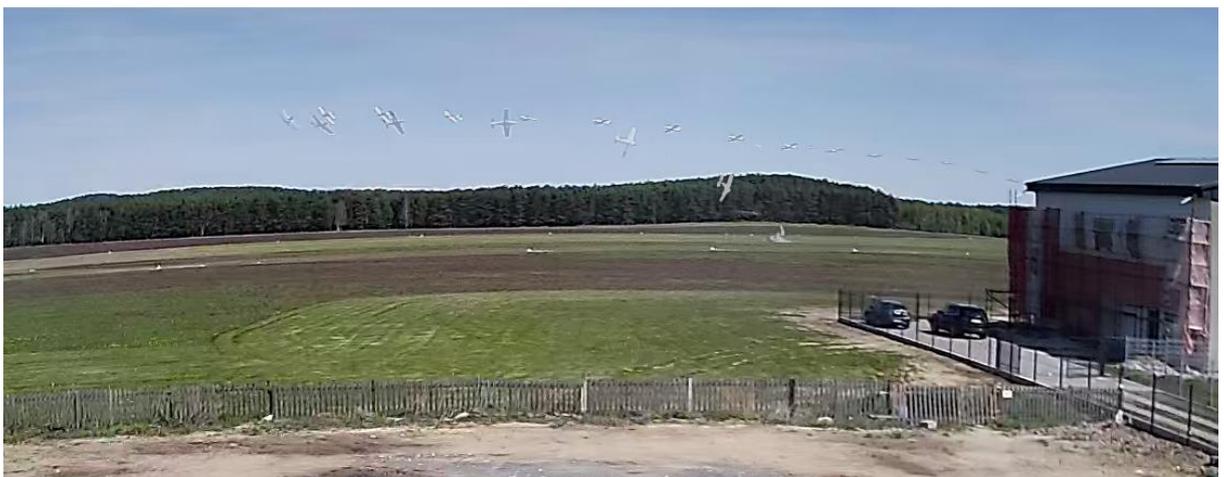
Fig. 1 shows a time-lapse recording of the airplane take-off.

Fig. 1 The course of the take-off reconstructed using time-lapse photography made at 1-second intervals

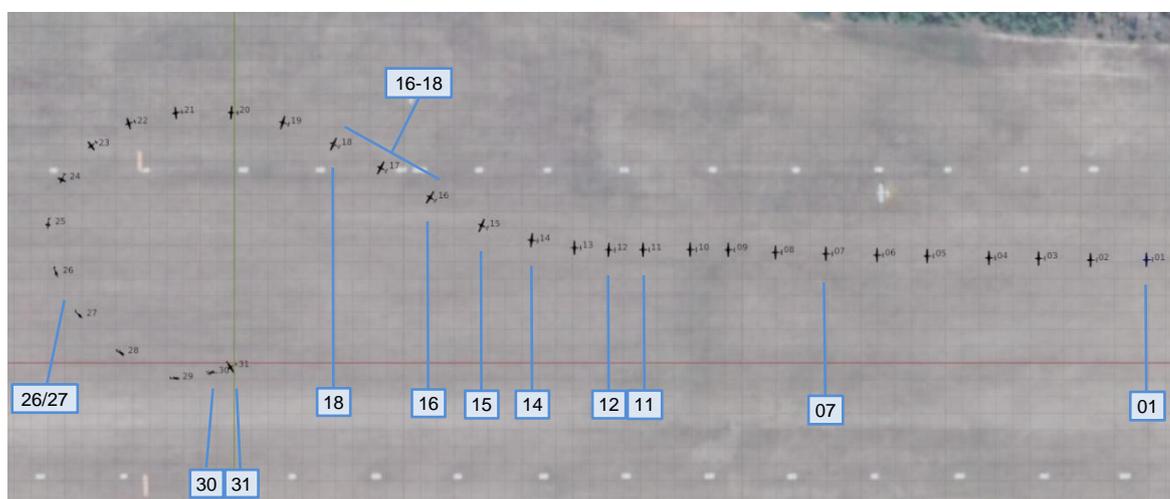
PKBWL used recordings from CCTV cameras installed on the AZL building and on a private building located on the outskirts of the aerodrome. Frames from both videos were assembled into a single image shown in horizontal plane in Fig. 5.

Fig. 5 Horizontal plane from position 01 [source: PKBWL analysis].

The locations of the airplane maneuvers and recorded phenomena (black and white smoke) that may have influenced the event are marked in Fig. 5.

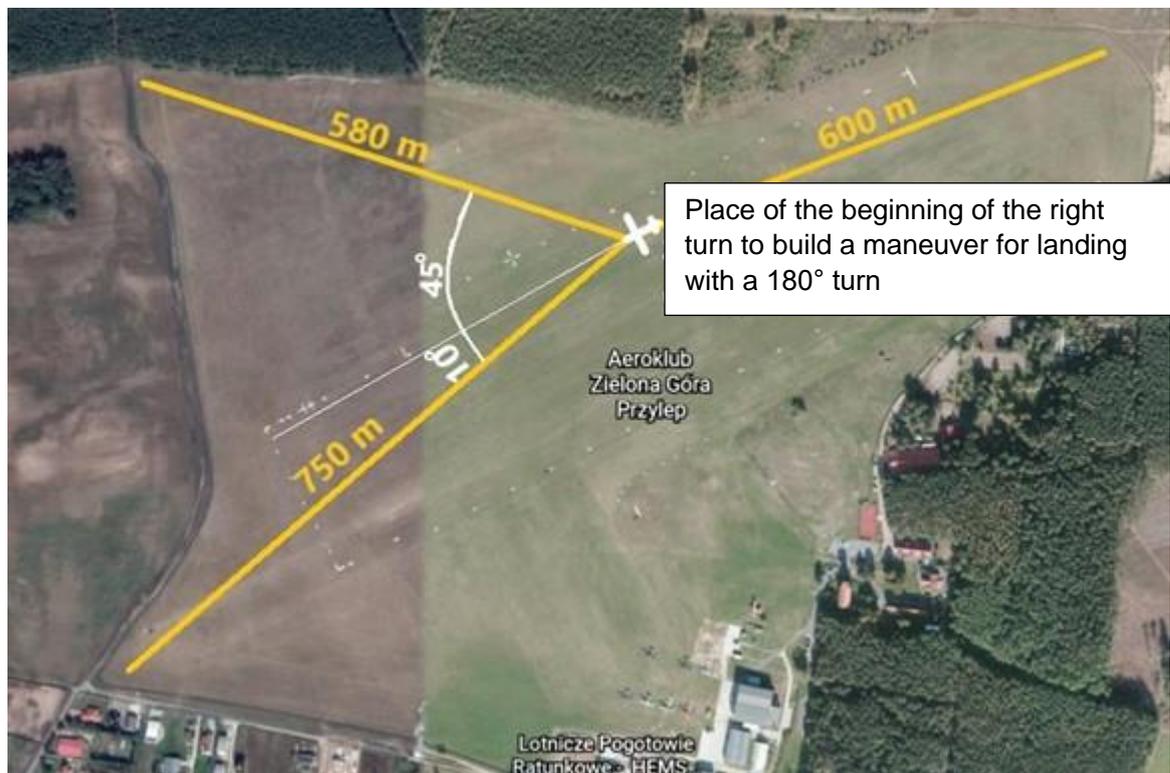
According to the Tecnam Astore AFM, after engine failure below 100 m, the pilot should gain secure speed (67 kt) by moving the stick "away" and land straight ahead with a possible deviation of the flight direction $\pm 45^\circ$ to the left or right. In the investigated case, the pilot should not make a 180° turn.

It was possible to perform a straight landing and a landing with a deviation to the left or right (Fig. 23).

Fig. 23. View of the aerodrome including the highlighted distance to its borders [source: PKBWL].

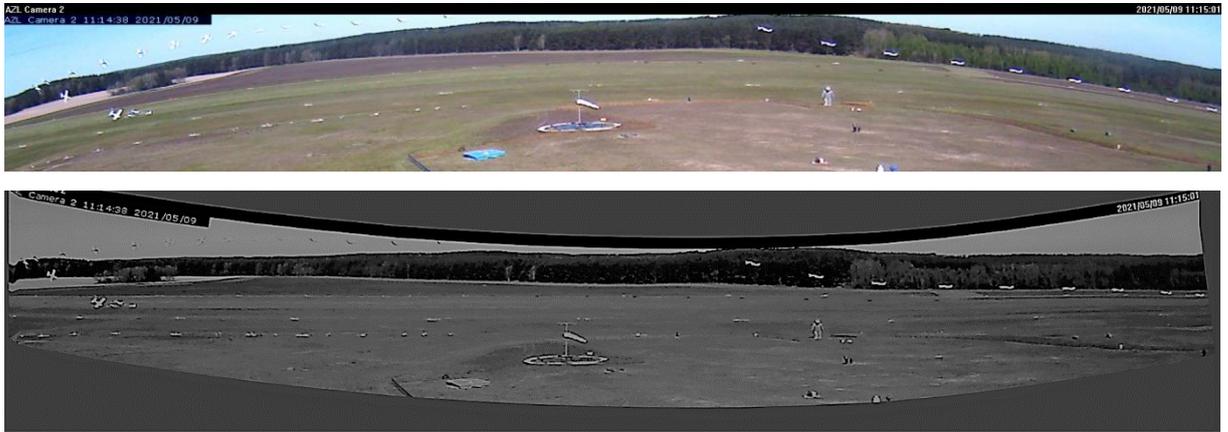
Fig. 24 Airplane positions at 1 s intervals based on the recording from TWR - original (top) and after geometry correction (bottom) [source: PKBWL analysis].

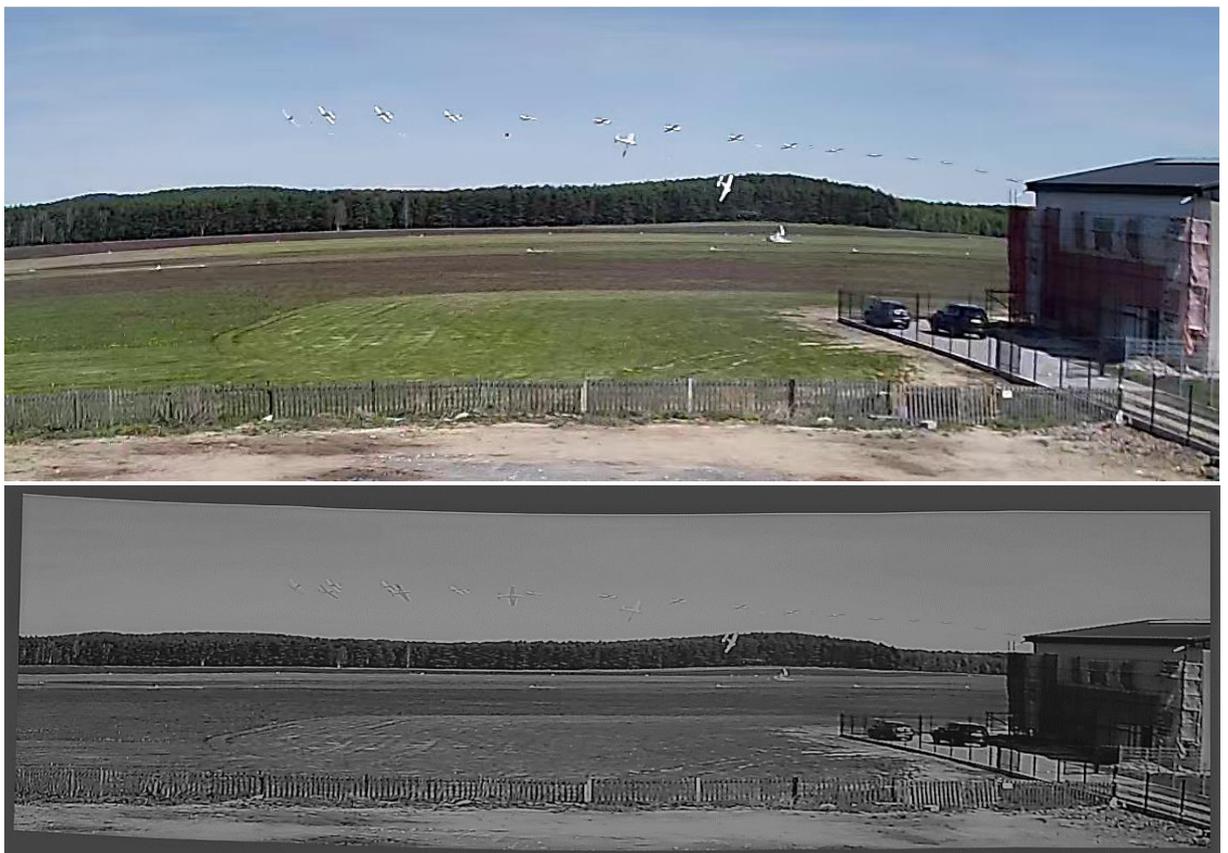
Fig. 25 Airplane positions at 1 s intervals based on the recording from the house on the outskirts of the aerodrome - original (top) and after geometry correction (bottom) [source: PKBWL analysis].

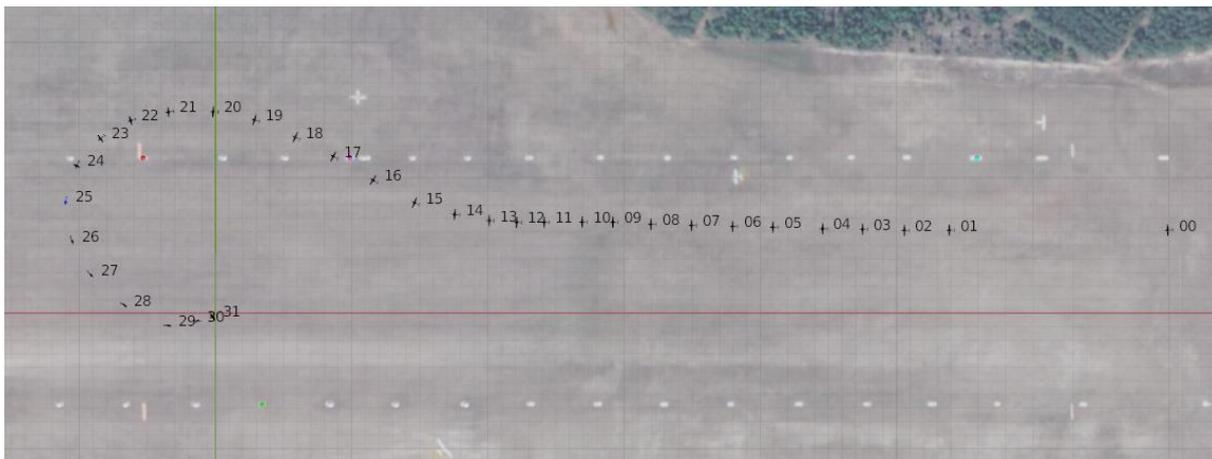
Based on the position of the cameras and the aerodrome objects, a model of the aerodrome was recreated in Blender (ver. 2.93.6) in a 1:1 scale. Then, the flight route of the airplane was reconstructed in the horizontal plane (Fig. 26). Positions 01-31 were determined based on the recordings. Position 00 was reconstructed based on the statement of the flight coordinator.

Fig. 26 Flight route horizontal projection plotted on the airfield model [source: PKBWL analysis].

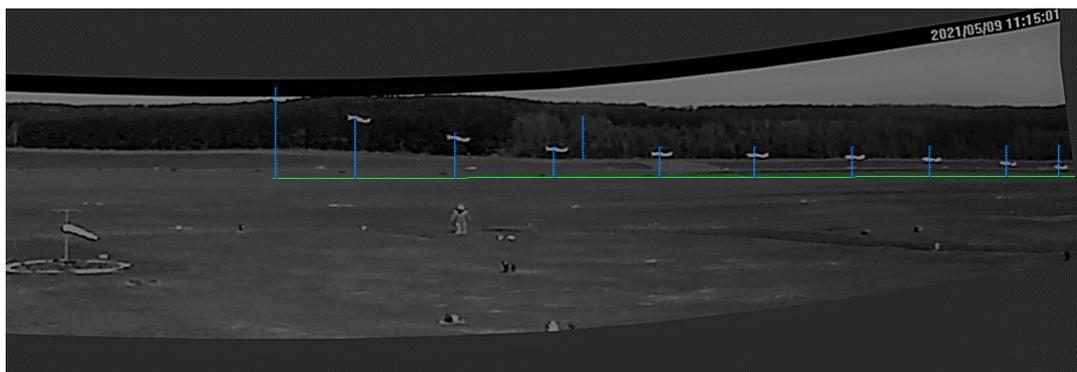
Because of the height of the trees (birches - 14 m) in the background of positions 01-07, the flight height was determined based on the converted measurement scale (Fig. 27).

Fig. 27 Determining the flight altitude by comparing the altitude to the tree height [source: PKBWL analysis].

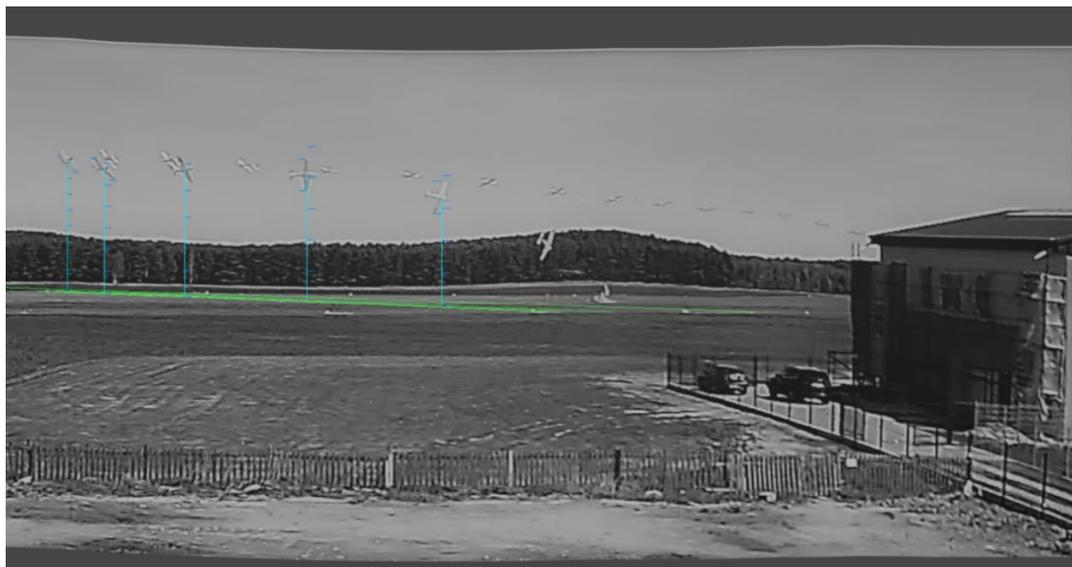
The height of positions 23-29 was determined by comparing the actual wingspan and the wingspan measured on the photograph.

Fig. 28 Establishing the flight height [source: PKBWL analysis].

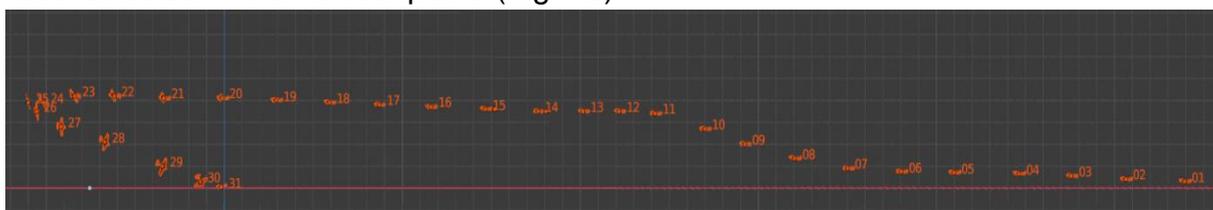
Once the height has been entered into the model, the flight path of the airplane was reconstructed in the vertical plane (Fig. 29).

Fig. 29 Side view of the flight route [source: PKBWL analysis]

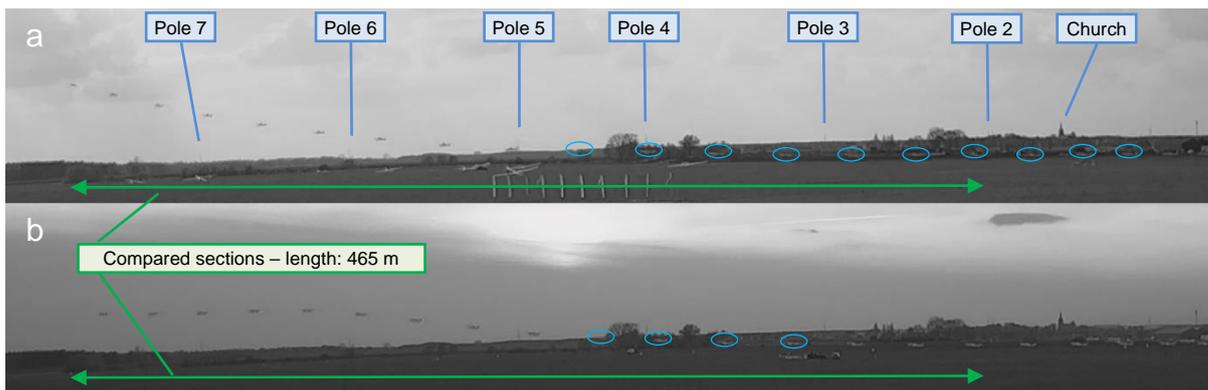
In addition to the footage of the accident take-off from the cameras at EPZP, the Investigation Team had access of the footage showing two Astore airplane take-offs on 8 May 2021 from EPLS aerodrome. The first video shows the take-off to perform the flight test after engine maintenance (Fig. 30 a) whereas the second video shows the take-off to perform the flight to the EPZP aerodrome (Fig. 30 b).

Fig. 30 The airplane positions at 1 s intervals on videos from the camera at EPLS [source: Google Earth, airplane take-off recordings].

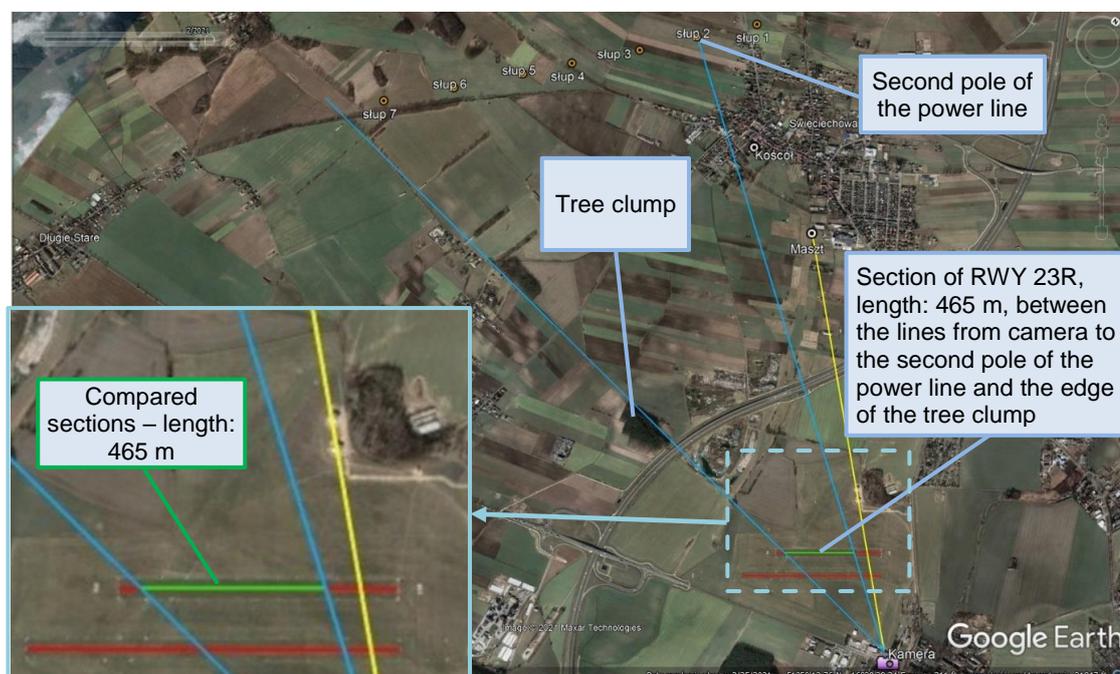
For the EPLS flights a section of 465 m starting from lift-off was selected. The position of the airplane on the background of landmarks was used to determine the measurement distance (Fig. 31).

Fig. 31 Sketch for the purpose of airplane speed calculation during take-off from EPLS [source: Google Earth, videos of airplane take-off].
