FINAL REPORT

2023-0008

Blue Sky Balloons, flight with passengers Cameron Balloons, Z-160, SP-BOK Bór, EPNT

Warsaw, 20 March 2024

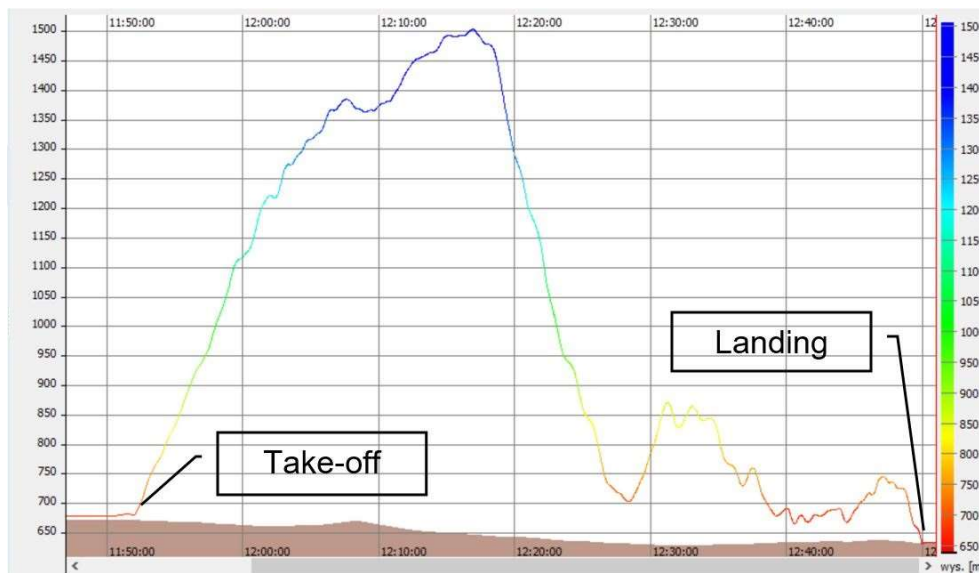
The flight proceeded normally. The balloon ascended to around 850 m AGL and for about 30 minutes travelled with the average speed of 10 km/h and maintained average heading of 35°. Subsequently, the pilot initiated a descent to around 150 m AGL, where the wind changed direction. The course of the flight from take-off to landing is depicted in the barogram below (Fig. 1).

Fig. 1. Barogram of the flight, AMSL [source: SeeYou]

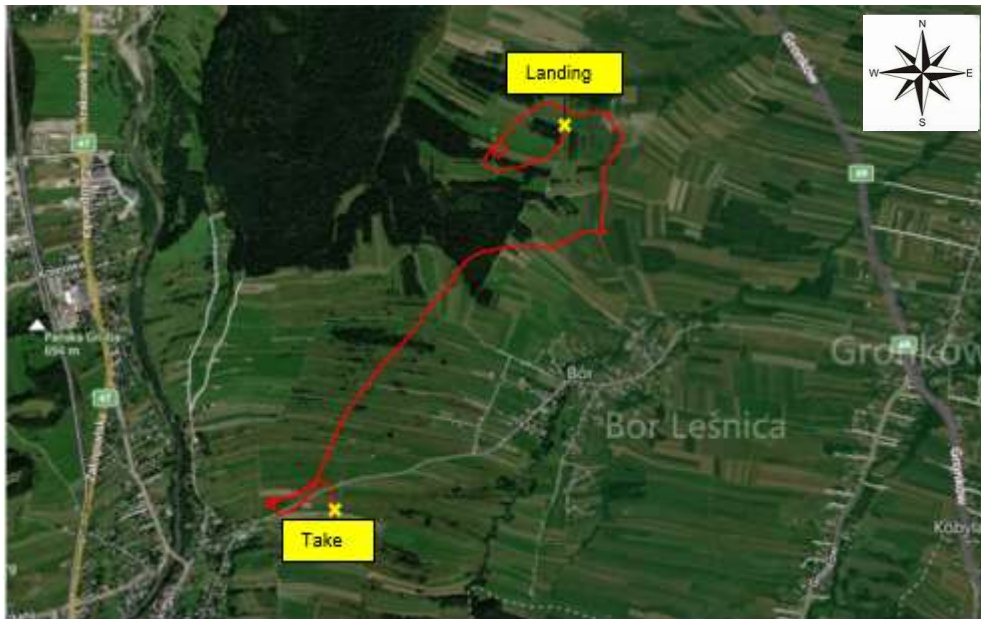
Fig. 2. Flight path of the SP-BOK balloon from take-off to landing [source: pilot – as recorded by the flight recorder]

After flying for 47 min (around 12 min before the planned landing), the balloon started moving in the south-west direction (S-W). Since there was a vast peatbog in the west, and the gas reserve did not guarantee flying over it, the pilot decided to initiate a landing.

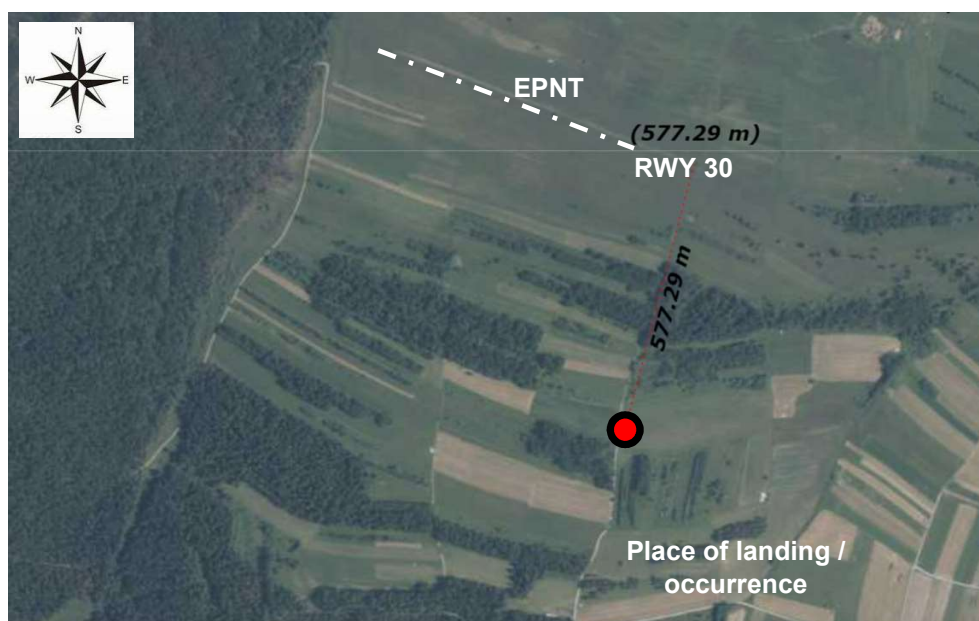
The landing took place at the edge of a grassy meadow, around 600 m to S from the start of RWY 30 at the EPNT aerodrome, close to a dirt road and an adjacent field fenced off from the road by a mesh fence (Fig. 6, see also Fig. 3).

Fig. 6. The place of landing/occurrence relative to the position of RWY 30 at the EPNT aerodrome [source: Geoportal]
