Reg. No.: SKA2011011

FINAL REPORT

on investigation of air accident
of aircraft type **CESSNA 150 L**
registration No. **SP-KDN**

Date: 20.08.2011

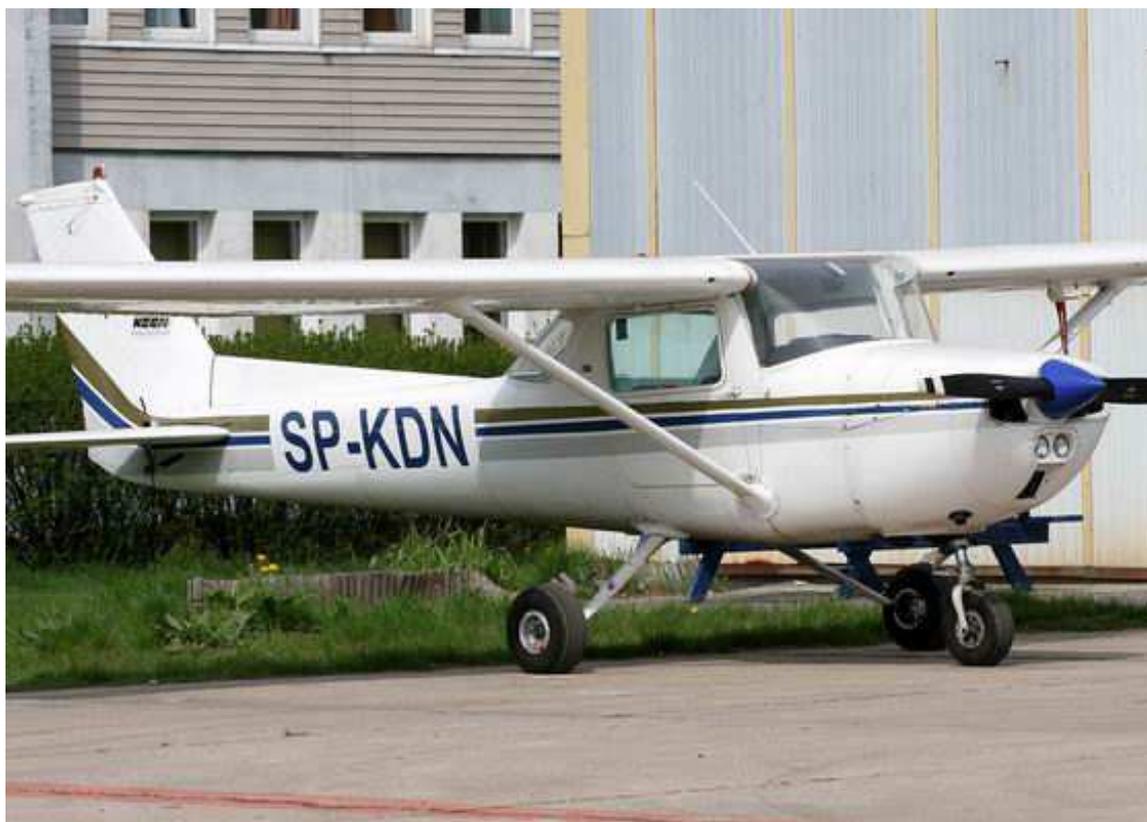
Immediately after the contact with the ground the aircraft slid along the concrete bridge over the reclamation canal in the clearway and under the influence of inertial forces continued the forward motion on the ground, until it stopped on RWY about 40 m away from its threshold. Before stopping the aircraft bent to the left side, rebounded from the left wing and stopped in the position, leaned on the engine in the landing direction.

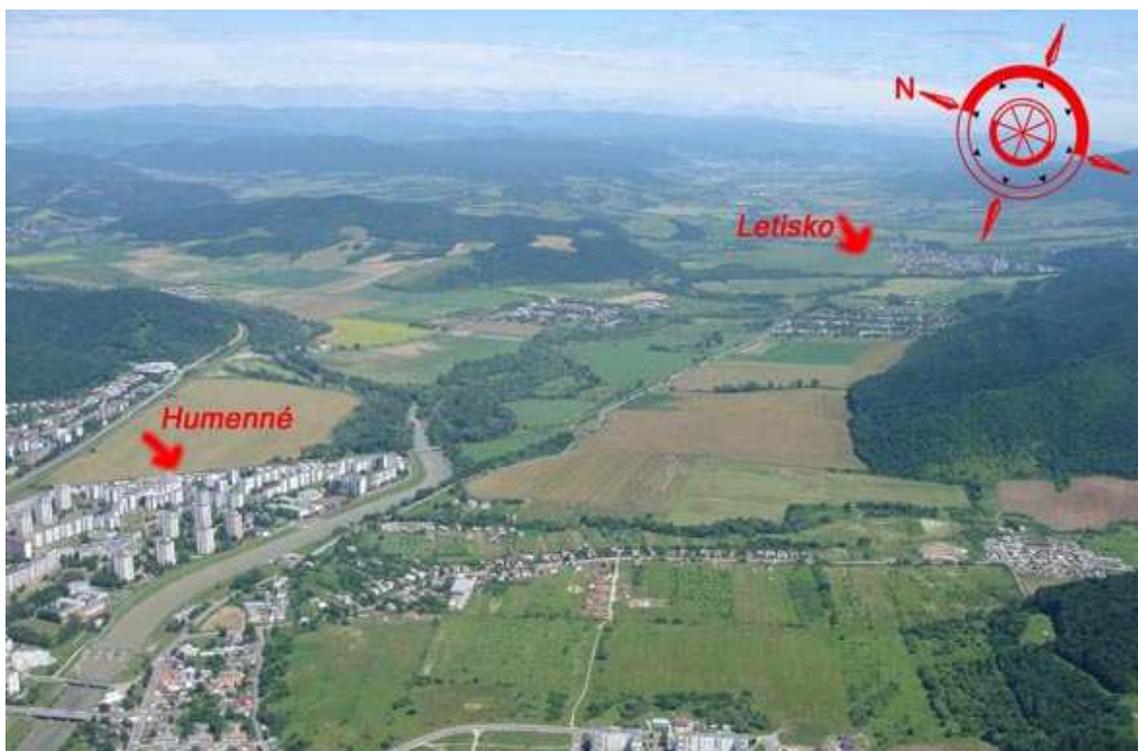
LZKC is a non-public domestic aerodrome with grass RWY, with dimensions of 850 m x 50 m.

The pilot making the approach landing incorrectly assessed the glideslope and during the descent manoeuvre did not react to the low altitude and large distance from the RWY threshold. Due to the premature start of flare-out approximately 200 m in front of the RWY threshold the aircraft was losing speed and then also height. The pilot did not react which ended by hard landing 30 m in front of the RWY threshold. The aircraft got damaged when it came into contact with concrete bridge over the reclamation canal in the RWY clearway.
