FINAL REPORT

ACCIDENT 580/16

AIRCRAFT – McDonnell-Douglas MD-500E helicopter, N60EP

DATE AND PLACE OF OCCURRENCE – 7 April 2016, Suwałki, Poland

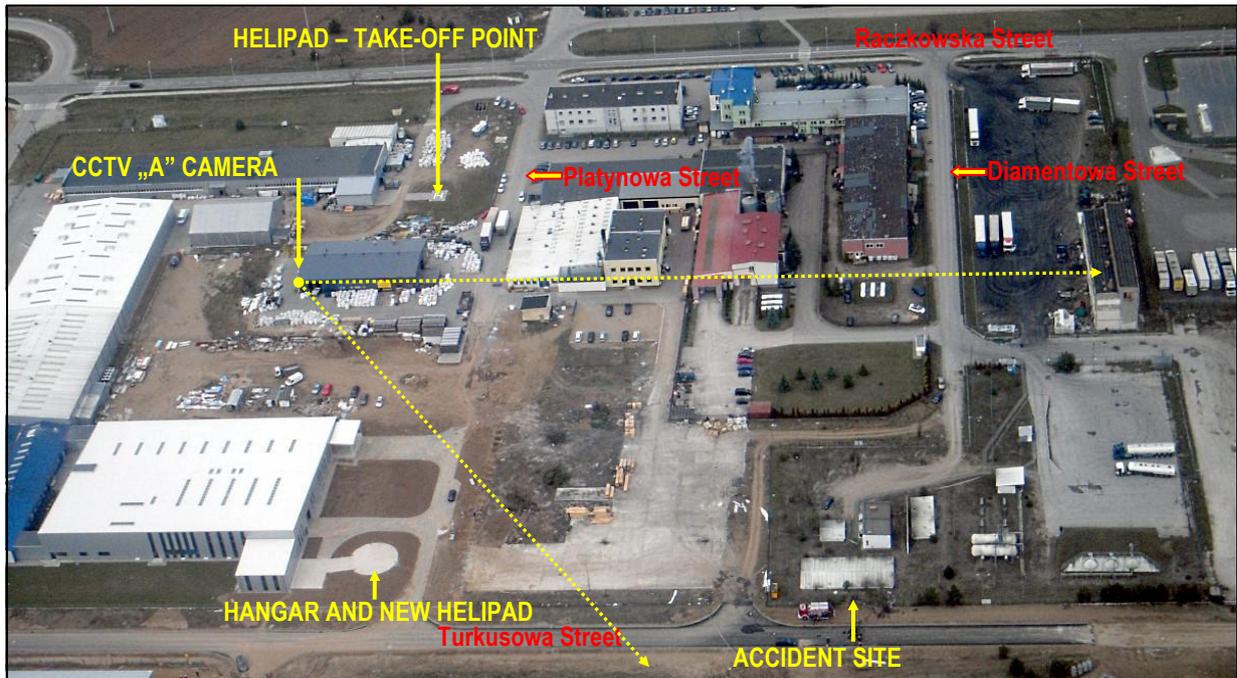
The helicopter took off from the helipad in front of a small hangar at Platynowa Street on the premises of Salag Sp. z o.o. and collided with the ground within the industrial zone south of Suwałki at Turkusowa Street near Diamentowa Street, approx. 230 m from the take-off point.

3 – Salag Sp. z o.o. premises – aerial photo. CCTV „A” camera angular range marked with yellow dotted line. Photos on Fig.[8] are from „A” camera. [photo.I.Przybyła, Suwalska Szkoła Lotnicza].

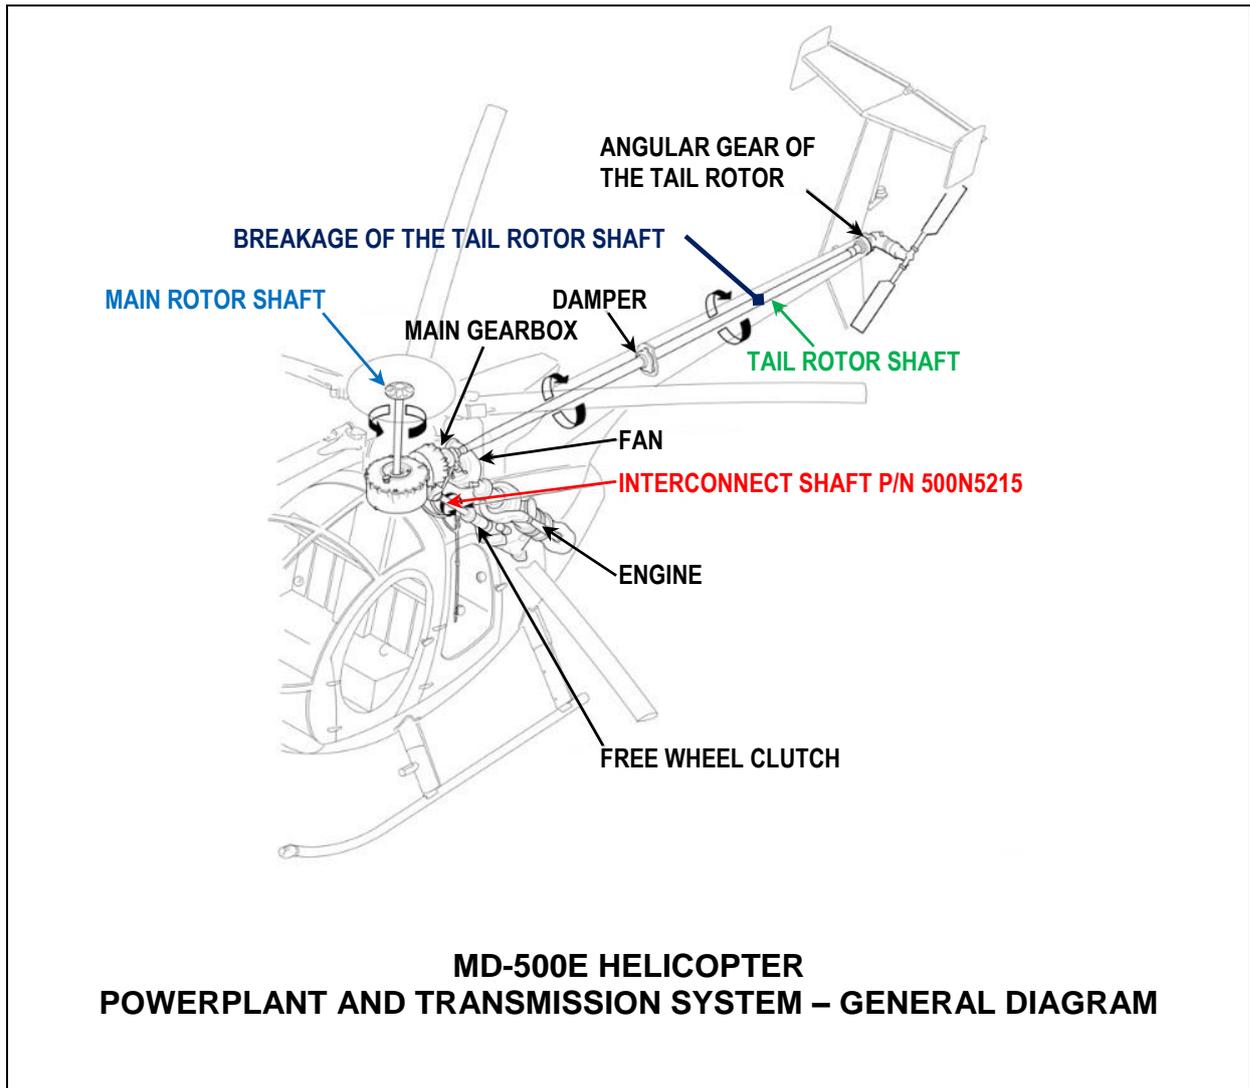
During the inspection of the helicopter at the scene the main rotor with deformed blades could be turned freely and without any effort around its axle; the tail rotor shaft also freely rotated inside the tailboom without any abnormal noises or resistance. It was concluded that the transmission system of the main rotor and tail rotor was not damaged (apart from the breakage of the tail rotor shaft as a result of its collision with the ground).

6 – Powerplant and transmission system of the MD-500E helicopter - general diagram.

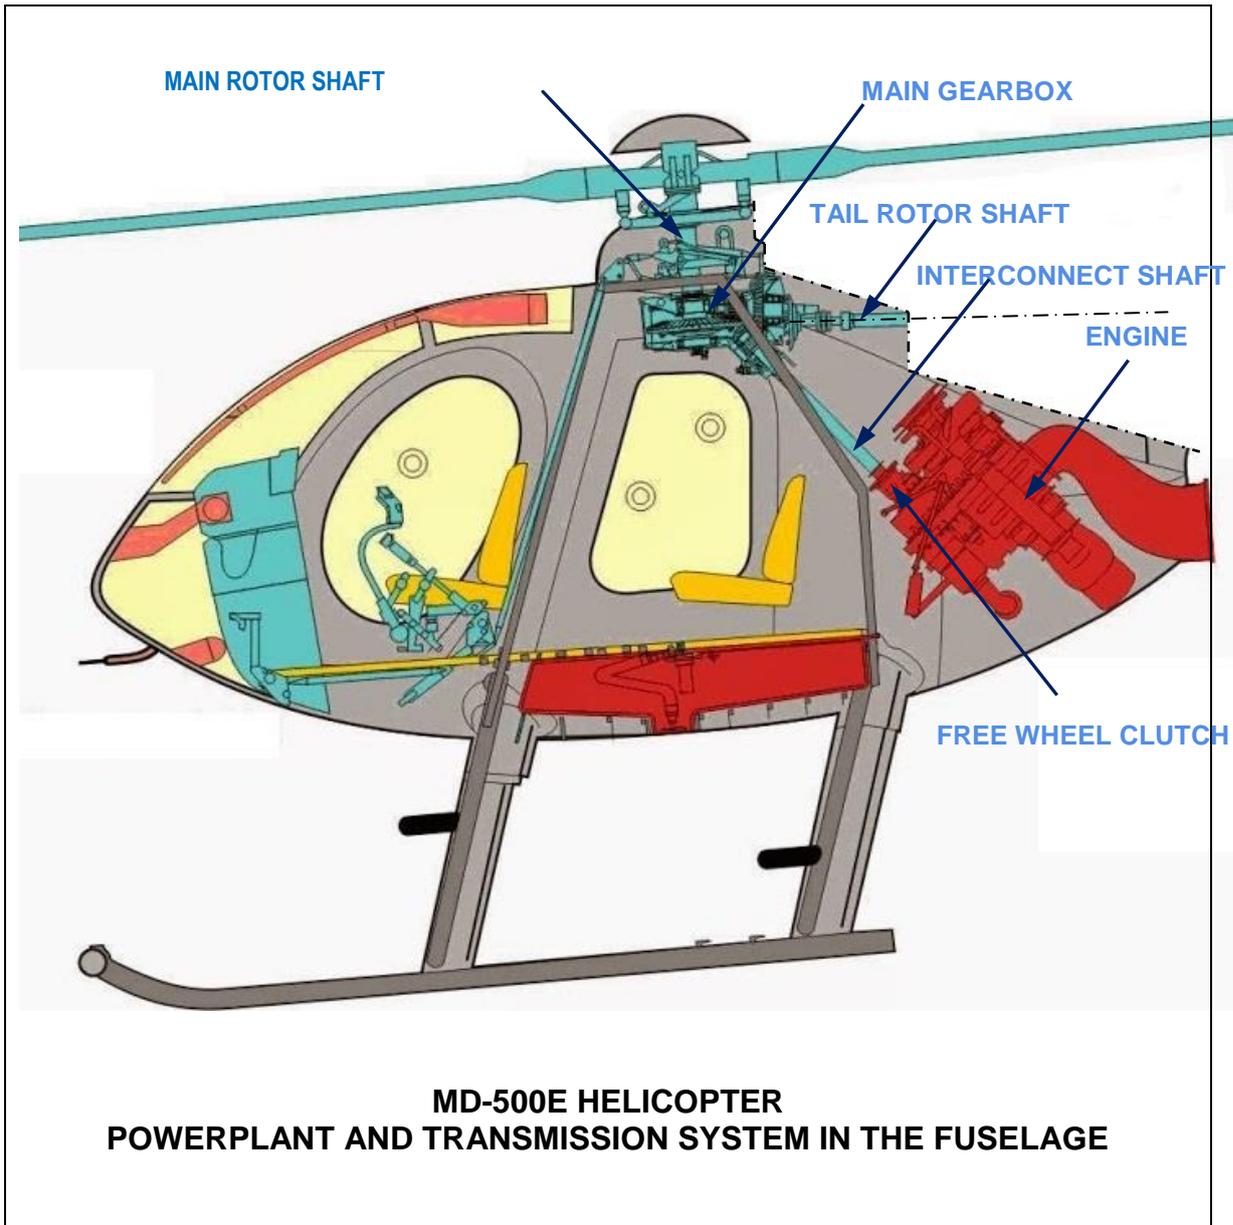
During an additional inspection of the helicopter wreckage, the Investigation Team conducted a detailed inspection of the interconnect shaft (P/N 50N5215) and its clutches (upper and lower). It was done at the request of the pilot, who expressed his assumption that the replacement of the shaft might have been effected in an improper way (it was the subject of maintenance works in the period immediately preceding the accident and was the only activity that might have had a technical impact on the occurrence).

No irregularities related to the interconnect shaft P/N 50N5215 were found.

7 – MD-500E helicopter powerplant and transmission system in the fuselage – general diagram

The replacement of the interconnect shaft P/N 50N5215 effected in the scope of 100H inspection on 10-12 November 2015, was the implementation of the Mandatory Service Bulletin of the helicopter manufacturer of 22 December 2010, covering its six versions. Numbering of this bulletin for each version of the helicopter was: SB369H-250, SB369D-208, SB369E-103, SB369F-088, SB500N-044 and SB600N-052.
