MINISTRY OF INFRASTRUCTURE
STATE COMMISSION ON AIRCRAFT ACCIDENT INVESTIGATION

FINAL REPORT

Serious Incident Occurrence No. 361/07

Clearance for take off despite a car on the runway Airbus A 320 airplane (TS-INF)

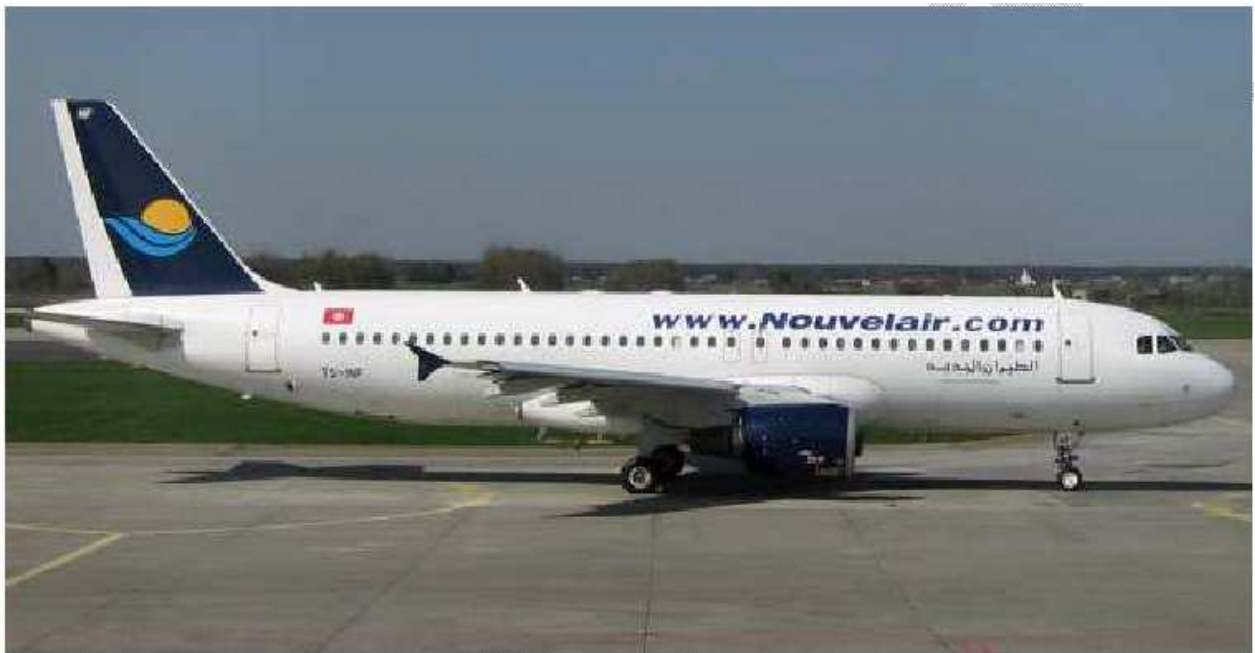
Airplane: Airbus A320

- Registration marks: TS-INF
- Serial number: 299
- Date of manufacture: 31 January 1992
- Maximum Take-Off Weight: 10319 kg
- User: Nouvelair Tunisie

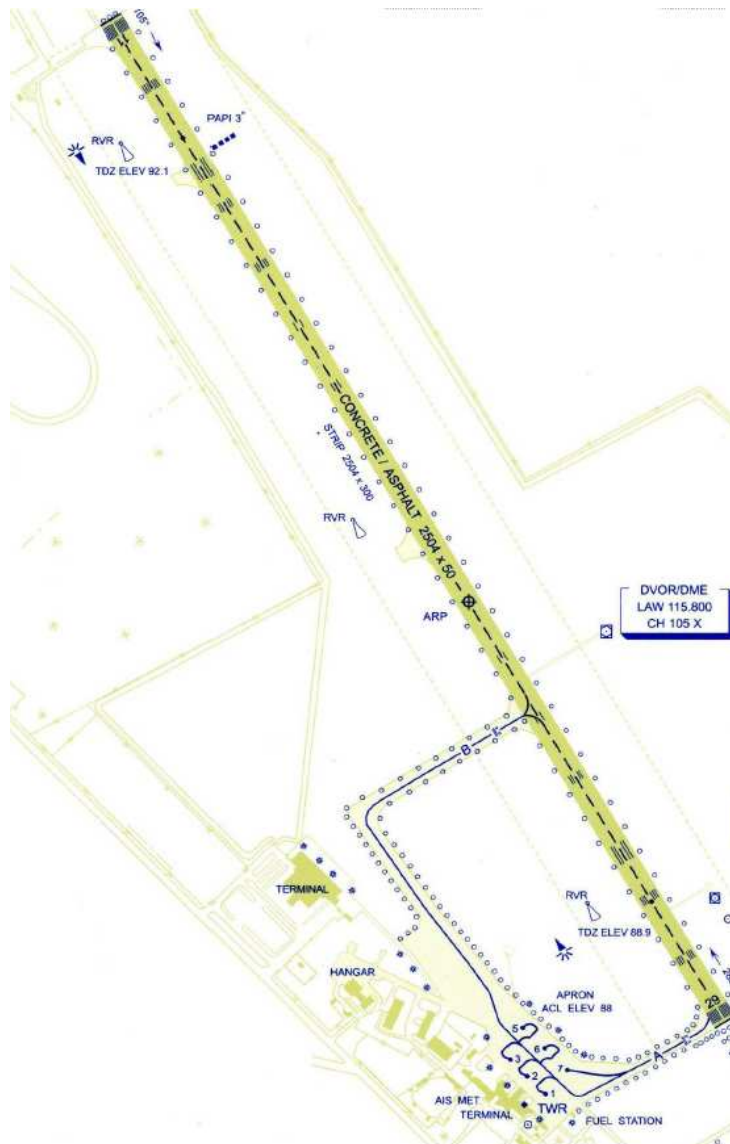
GEOGRAPHICAL DATA:

1. ARP – WGS-84 coordinates and location: 52°25.15.71”N 016°49.34.77”E – RWY central line, 1055 m from THR 29.
2. Distance, direction from the city: 5 km (2,7 NM), BRG 288° GEO.
3. Airport elevation/Reference temperature: 94 m; 24,4°C (JUL).
4. Runway 11/29 dimensions: 2504 x 50 meters.
5. Strength of runway surface: PCN 44/F/A/X/T asphalt/concrete.
